**US Army Corps
of Engineers®**
Engineer Research and
Development Center

Feasibility Investigation into Strengthening of Timber Bridge Stringers

Final report

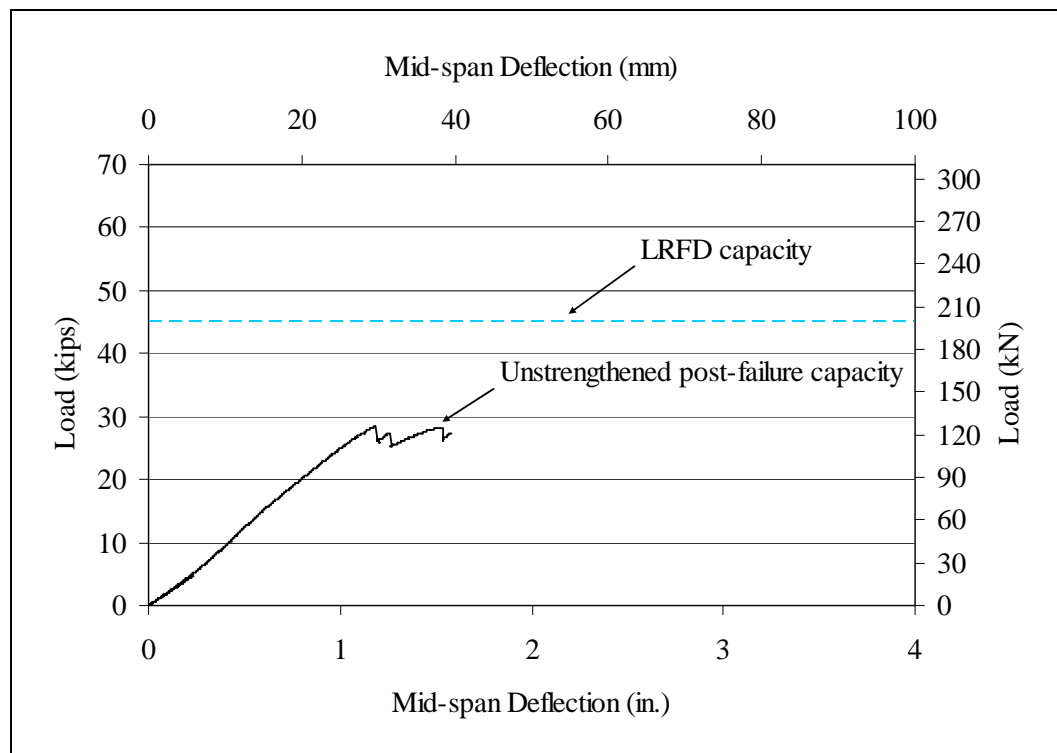
Stringer C13 had end splitting prior to testing. The stringer showed horizontal sliding on the support face as the load increased. The load-deflection curve of the stringer, shown in Figure 89, was linear until the stringer reached the unstrengthened postfailure capacity of 125 kN (28 kips) at a deflection of 39 mm (1.53 in.). With a decreased stiffness, the load increased further. The stringer underwent additional deflection while developing tension cracks.

Figure 89. Load-deflection curve for stringer C13.

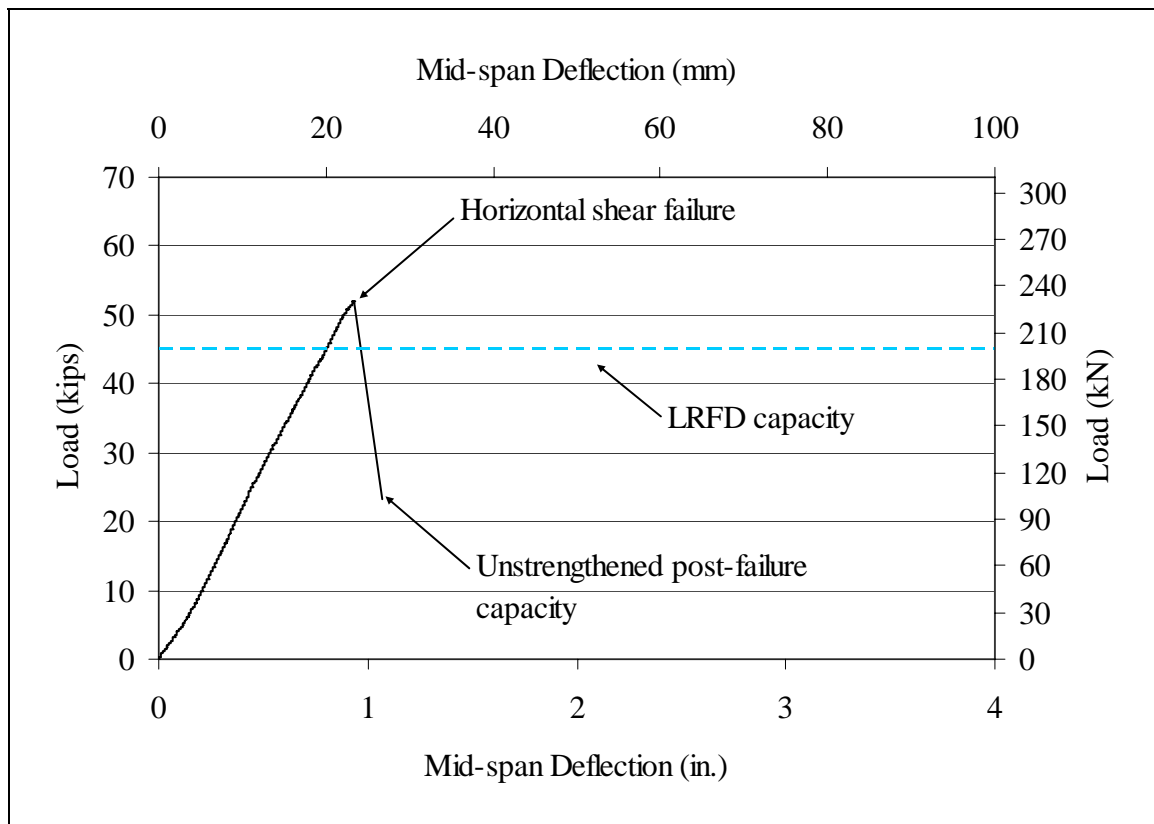
Stringer C14 had signs of heart checks prior to testing. The stringer behaved linearly until it reached its ultimate load capacity, as seen in the load-deflection curve shown in Figure 90. The stringer failed in horizontal shear. The ultimate load was 231 kN (52 kips) at a displacement of 24 mm (0.94 in.). The unstrengthened postfailure capacity was 102 kN (23 kips). Horizontal sliding was observed on the cross section after the horizontal shear failure, as shown in Figure 91. Horizontal splitting occurred at the center of the cross section where shear stresses reached their maximum value.

Figure 90. Load-deflection curve for stringer C14.

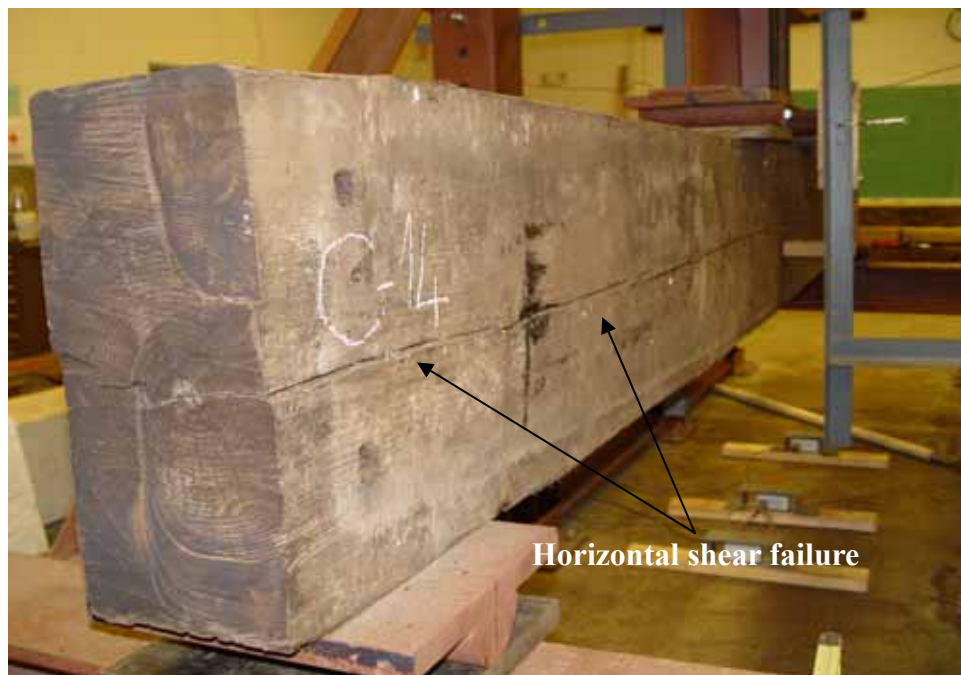
Figure 91. Horizontal shear failure on stringer C14.

Horizontal shear failure occurred near the center of the cross section where the shear stresses were at a maximum. Timber stringers C10 and C14, both with heart checks, were the best example for this type of failure. As expected, these stringers developed shear failure parallel to grain along the heart checks. Stringers C10 and C14 then began to act like two separate beams, one sliding on top of the other. This supported the assumptions in Chapter 3, "Experimental program, Repair systems for stringers," which were used to determine the required number of hex bolts or lag screws. Full longitudinal separation was assumed along the length of the stringers in the previous calculations. Splitting was not over the entire lengths of the stringer used in the experiments. A smaller number of hex bolts or lag screws were also feasible to repair timber stringers.

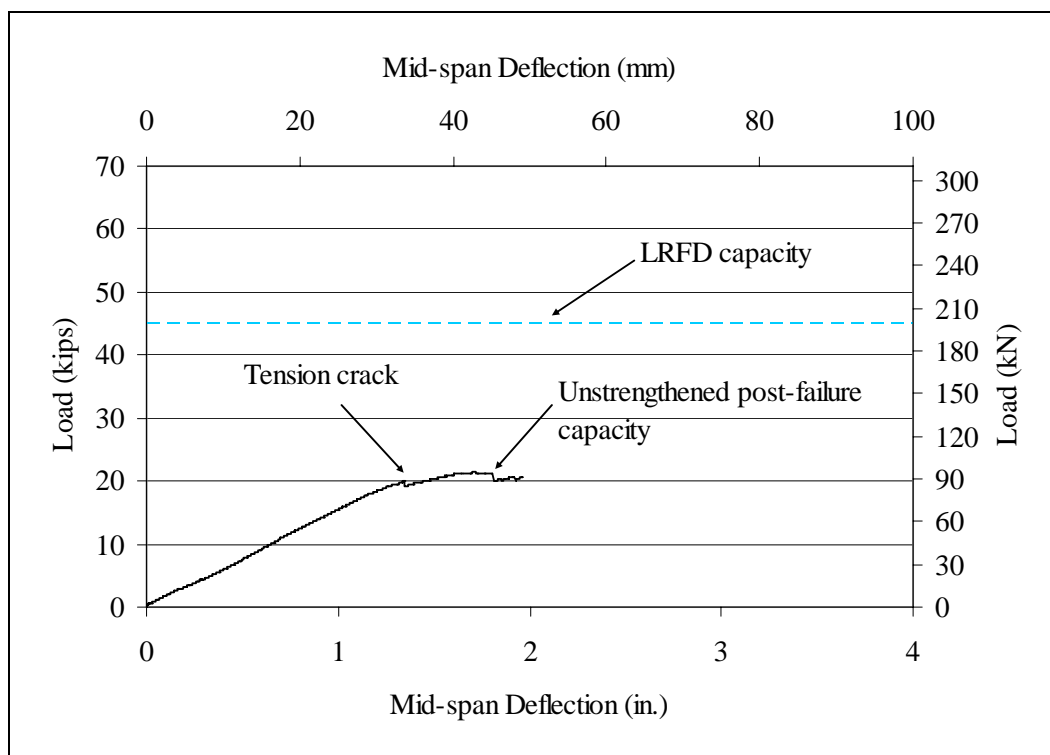
Horizontal sliding was observed at the support faces of stringer C15 as the load increased due to horizontal end splitting. The initial slope of the load-deflection curve for stringer C15, shown in Figure 92, was linear until the timber cracked in the tension zone at a load of 89 kN (20 kips). This caused a small drop in the supported load to 85 kN (19 kips). The stringer then underwent additional deflection of 13 mm (0.5 in.) with increasing load. Several additional horizontal cracks were formed because of the excessive deformation in the stringer. The unstrengthened postfailure capacity was 93 kN (21 kips). The experiment was terminated at the postfailure capacity in order to prevent the formation of additional tension cracks.

Figure 92. Load-deflection curve for stringer C15.

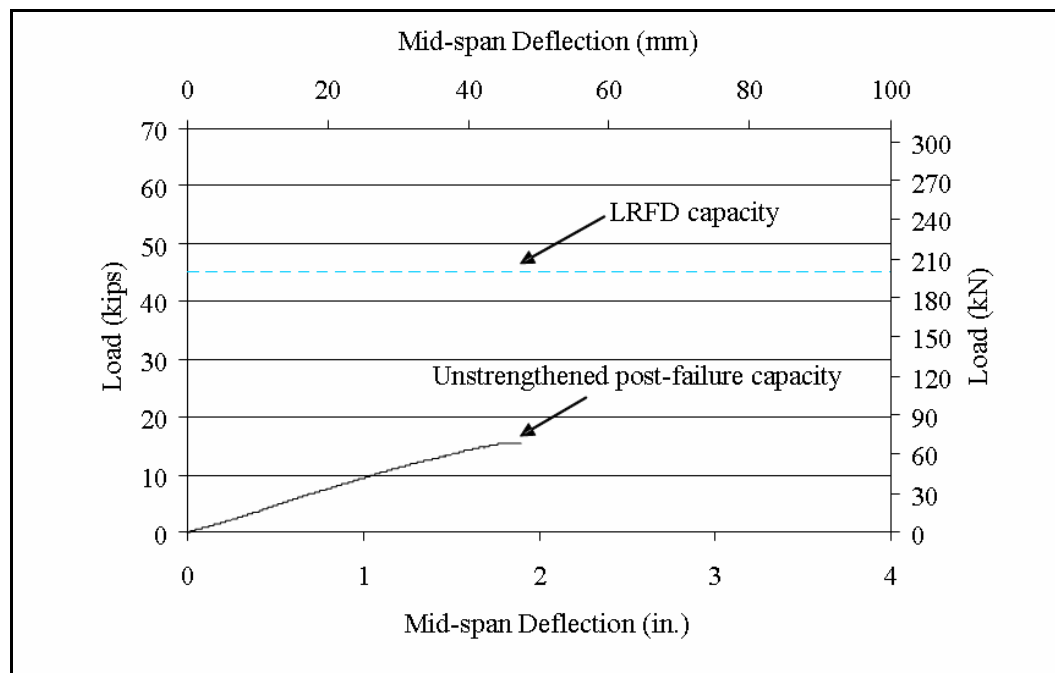
Stringer C16 exhibited end splitting prior to testing. The stringer behaved linearly until the unstrengthened postfailure capacity, as seen in the load-deflection curve given in Figure 93. Horizontal sliding on the support face was observed as the load increased throughout the test. The unstrengthened postfailure capacity was 67 kN (15 kips). The experiment was

terminated to prevent the formation of tension cracks after the postfailure capacity was reached.

Figure 93. Load-deflection curve for stringer C16.

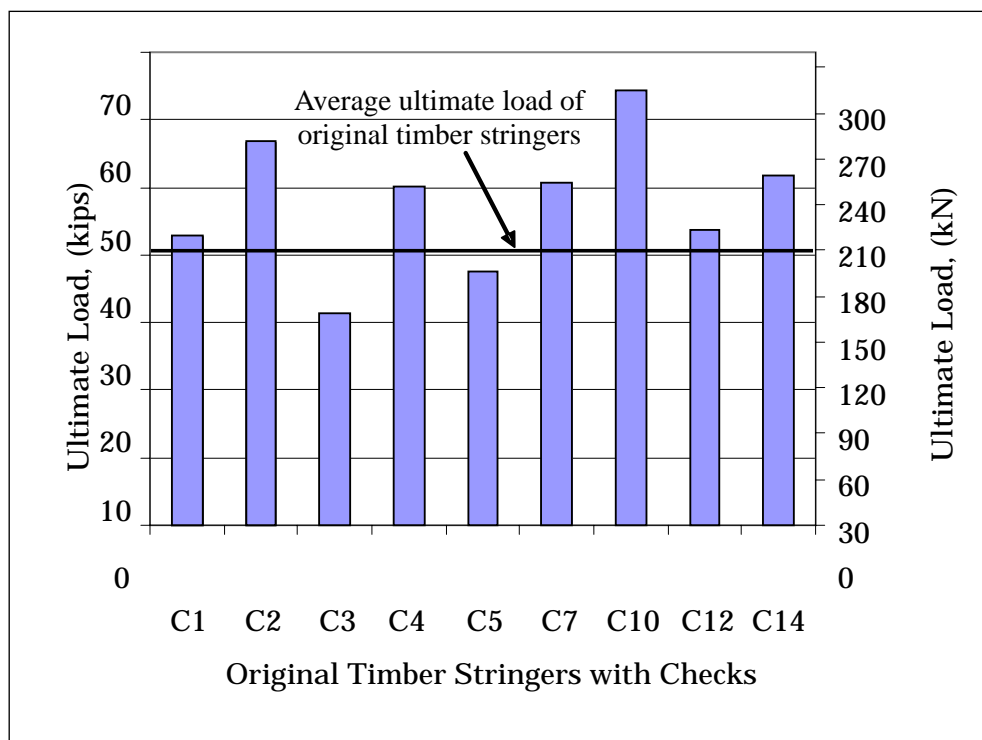
The ultimate strength distribution for the original stringers without end splitting before testing was shown in Figure 94. The ultimate strength values obtained from these stringers ranged from 142 kN (32 kips) for the weakest stringer C3 to 285 kN (64 kips) for the strongest stringer C10. An average ultimate load was 180 kN (40.5 kips) for original timber stringers. The variation was expected because these stringers have been in service for decades and were exposed to severe weather conditions. Based on the limited number specimens, it is appropriate to determine trends rather than concentrating on specific values such as the average.

Figure 94. Distribution of ultimate load for original stringers without end splitting.

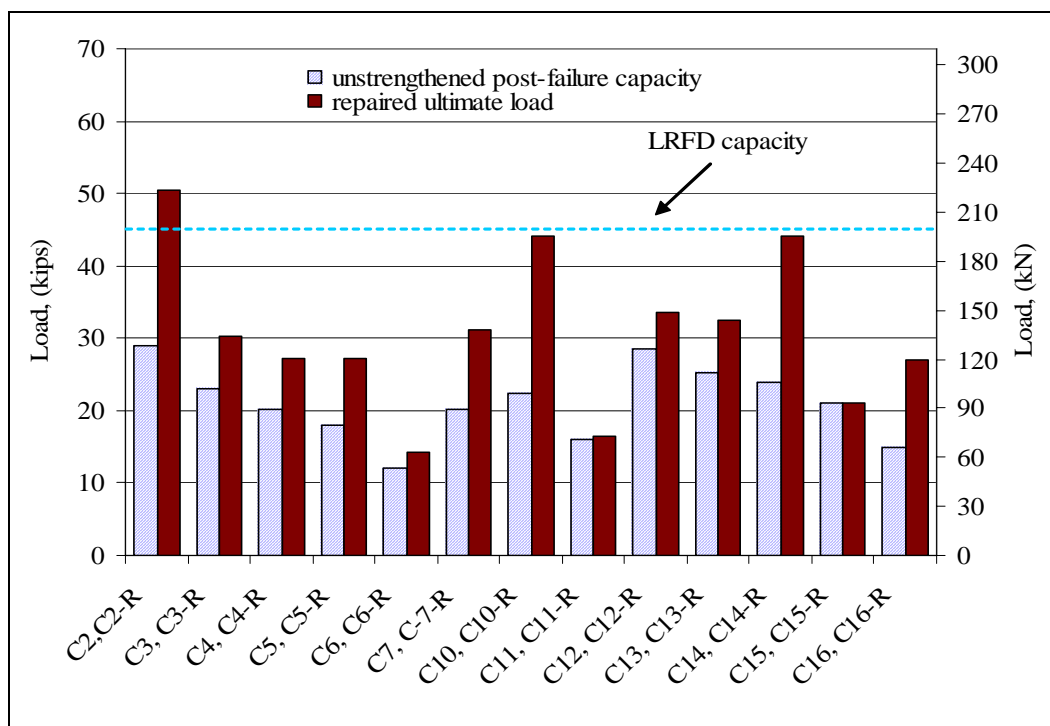
This section reviews the experimental results for the repaired stringers. The repaired ultimate load capacity of the repaired timber stringers was compared with the unstrengthened postfailure capacity of original stringers to determine the effectiveness of the repair methods, as shown in Figure 95. The use of hex bolts, lag screws, and FRP side plates increased the unstrengthened postfailure capacity of the repaired timber stringers. None of the repair methods was adequate to restore the load capacity of the repaired stringers to the original unsplit member strength, as seen in Figure 96. Increase in strength over unstrengthened postfailure capacity was 100% for stringer C10-R. The minimum percent strength increase over unstrengthened postfailure capacity was 4.8% for stringer C15-R.

Figure 95. Unstrengthened postfailure capacity and repaired ultimate load capacities.

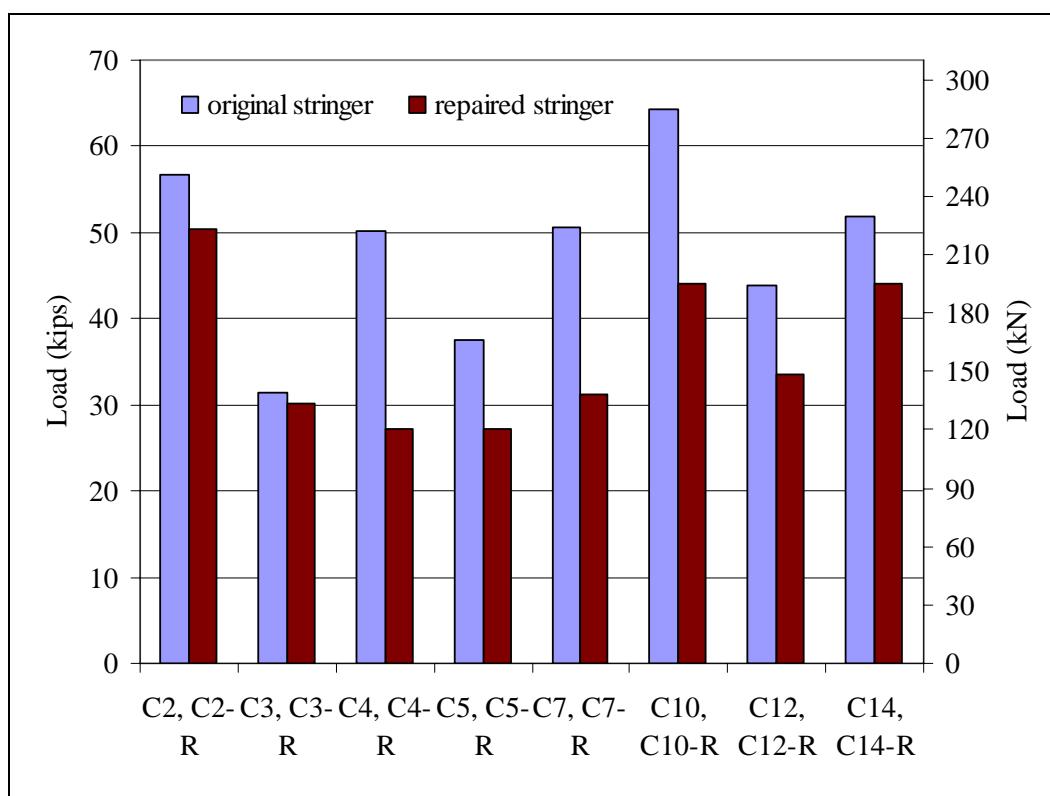
Figure 96. Ultimate load of original and repaired stringers without end split before testing.

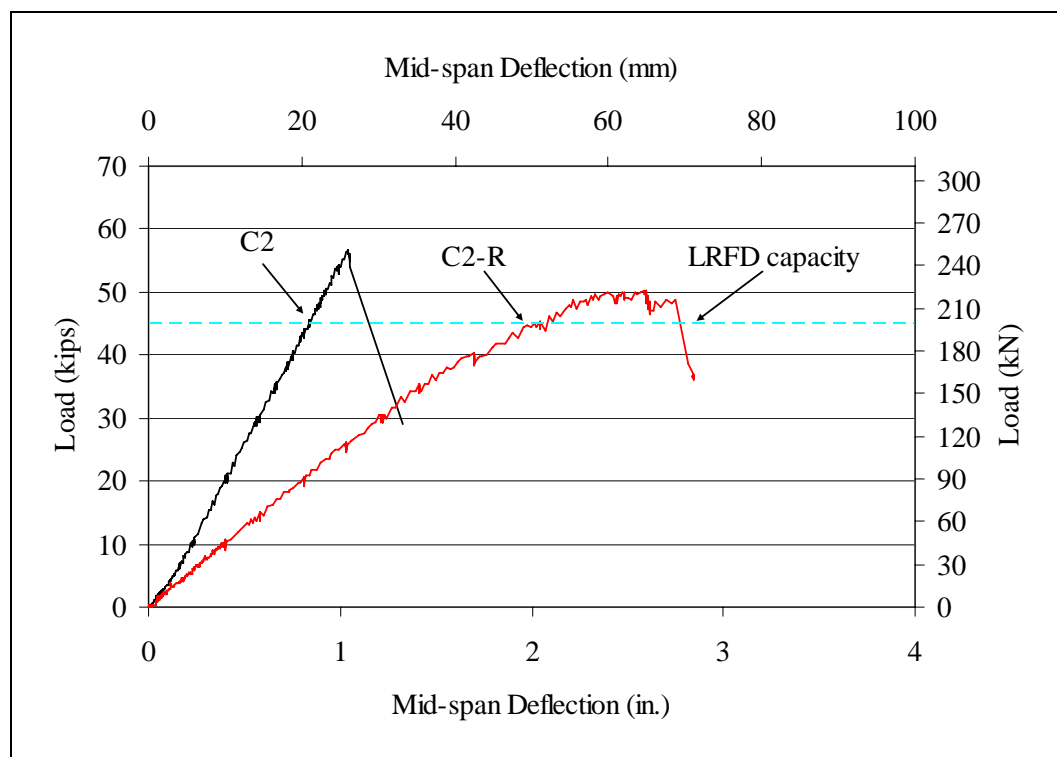
The load-deflection curve for stringer C2-R, shown in Figure 97, was linear until the stringer C2-R cracked in the tension zone which caused a drop in its load capacity. Cracking noise was heard and horizontal sliding was observed at the support face as the load increased to failure. Stringer C2-R had tension cracks and tension splinters at the midspan at the repaired ultimate load, as shown in Figure 98. The repaired ultimate load was 222 kN (50 kips) at a displacement of 66 mm (2.6 in.).

Figure 97. Load-deflection curves for stringers C2 and C2-R.

The increase in the repaired ultimate load over the unstrengthened postfailure capacity was 72.4 and 30.4% for repaired stringers C2-R and C3-R, respectively. These stringers were repaired using hex bolts at every 610 mm (2 ft) with epoxy. The epoxy used on the surface of the hex bolts improved the load transfer between the timber and the hex bolts. Since stringers C2 and C3 developed horizontal shear cracks prior to the repair, the repair method was effective. The original and repaired ultimate loads were 254 kN (57 kips) and 222 kN (50 kips) for stringers C2 and C2-R, respectively. This represents 88% recovery of ultimate load for stringer C2-R, and the increase in the unstrengthened postfailure capacity was 72.4%. The repair method was effective because the initial failure of stringer C2 was only in horizontal shear and; therefore, effectiveness of the shear repair method was maximized for stringer C2-R.

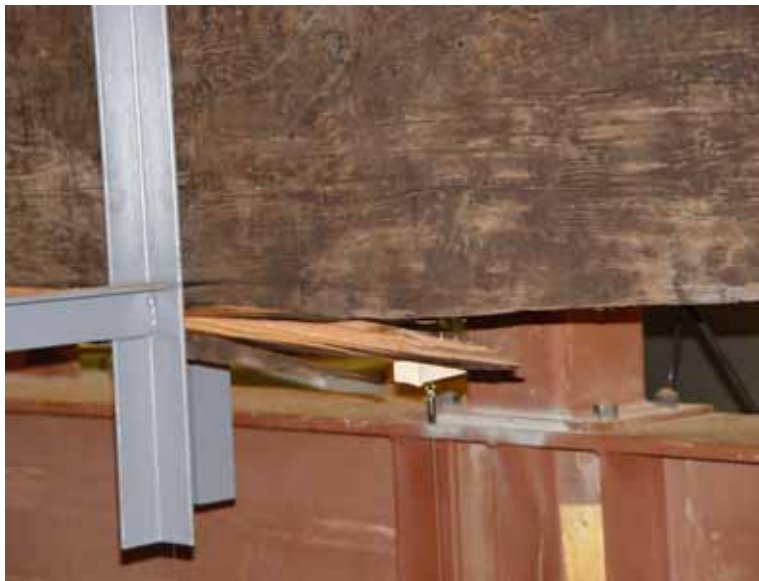
Figure 98. Tension cracks at the failure on stringer C2-R.

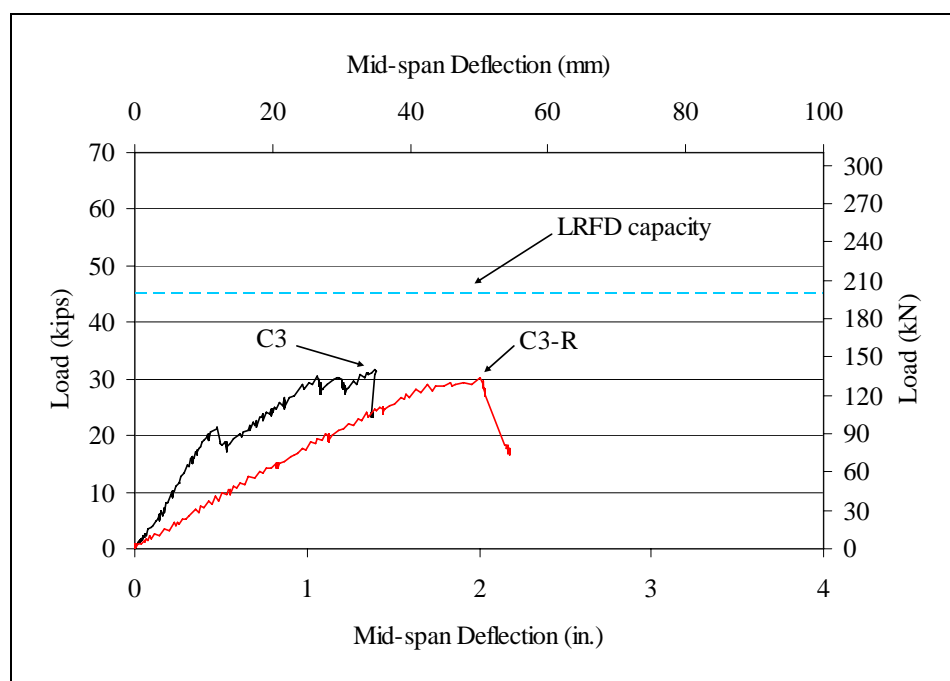
Stringer C3-R behaved linearly until it reached the repaired ultimate load, as seen in the load-deflection curve shown in Figure 99. The stringer failed in horizontal shear, which caused a drop in its load capacity. Horizontal sliding was observed at the support faces, as the load increased to failure. The repaired ultimate load was 133 kN (30 kips) at a displacement of 51 mm (2 in.).

Figure 99. Load-deflection curves for stringers C3 and C3-R.

The original and repaired ultimate loads were 142 kN (32 kips) and 133 kN (30 kips) for stringers C3 and C3-R, respectively. Stringer C3-R with hex bolts and epoxy recovered 94% of ultimate load of stringer C3. Effectiveness of stringer C3-R was lower than stringer C2-R because of the tension cracks that developed during testing of stringer C3, as explained in Chapter 5, "Test results and discussion, Test results of original stringers, Specimen C3." Two tension cracks occurred in stringer C3 as the load increased to failure to 93 kN (21 kips) and 133 kN (30 kips). At failure, a horizontal shear crack was visible in this stringer. Using hex bolts with epoxy did not restore the stiffness of stringers C2-R and C3-R to their original unsplit stiffness.

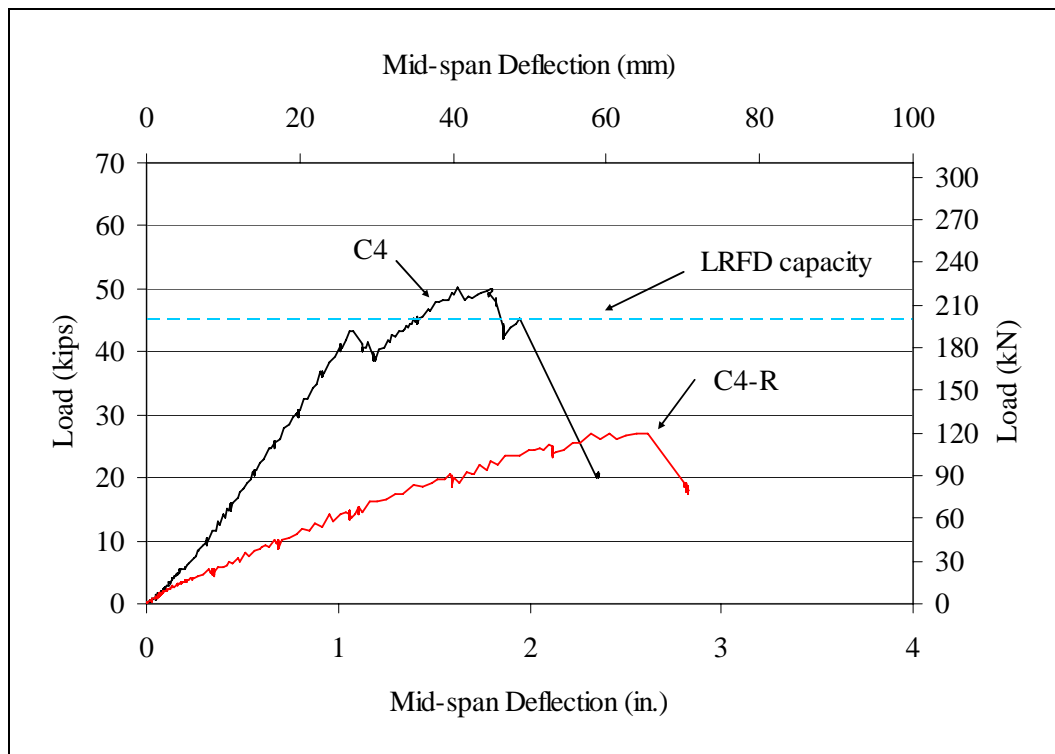
The load-deflection curve for stringer C4-R, shown in Figure 100, was linear until the stringer cracked in the tension zone. Cracking noise was heard and horizontal sliding was observed at the support face as the load increased to failure. The stringer had cross-grain tension cracks and tension splinters near the midspan at failure, as shown in Figure 101. The repaired ultimate load was 120 kN (27 kips) at a displacement of 67 mm (2.63 in.).

Figure 100. Load-deflection curves for stringers C4 and C4-R.

The increase in the repaired ultimate load over the unstrengthened post-failure capacity was 35% for repaired stringer C4-R. This value was near the percent increase observed for timber stringer C3-R which was 30.4%. Stringer C4-R was repaired with hex bolts and epoxy at every 305 mm (1 ft). Decreasing the spacing from 605 mm (2 ft) to 305 mm (1 ft) did not significantly improve the repaired ultimate load of the timber stringers. The original and repaired ultimate loads were 222 kN (50 kips) and 121 kN (27 kips) for stringers C4 and C4-R, respectively. This represents 54% recovery in the ultimate load capacity of stringer C4-R. The increase in the unstrengthened postfailure capacity and recovery of the ultimate load was low because of the cross-grain tension cracks that developed in stringer C4 and affected the repair method as compared to the repaired stringer C2-R. Cross-grain tension failure in stringer C4 reduced the recovery of the repair ultimate load on the stringer C4-R, although the unstrengthened postfailure capacity increased by 35% from 89 kN (20 kips) to 121 kN (27 kips). Recovery of the ultimate load with respect to stringer C4 was low for stringer C4-R, and the stiffness of stringer C4-R was not enhanced compared with stringer C4.

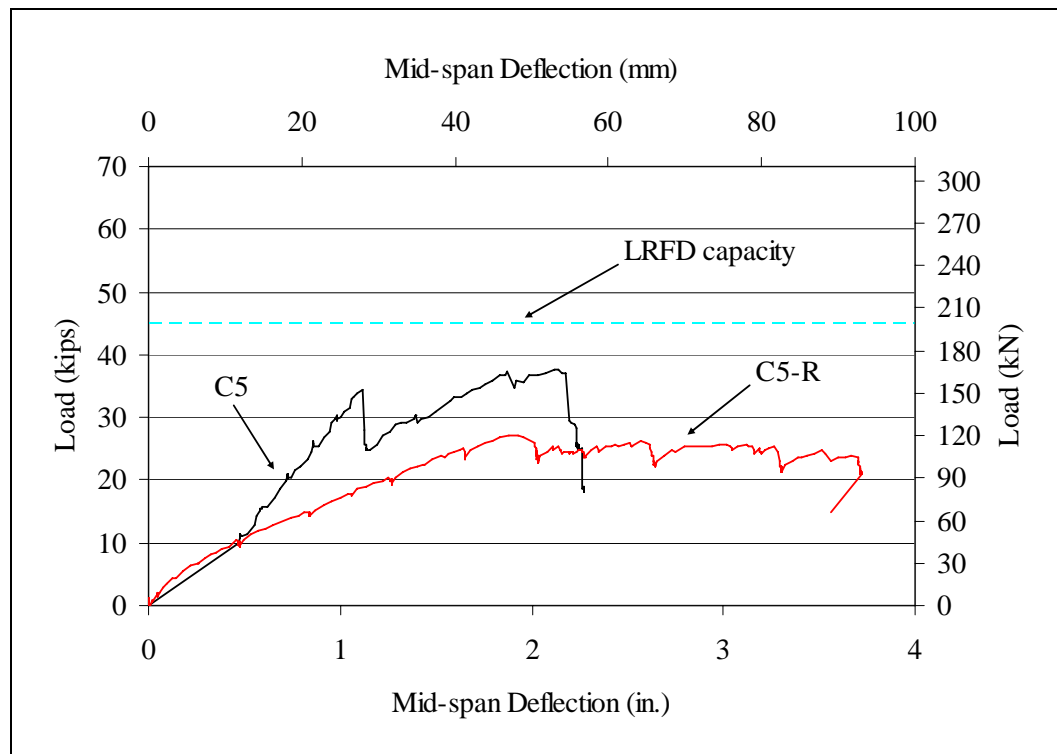
The load-deflection curve for stringer C5-R, shown in Figure 102, was linear until the stringer cracked in the tension zone at the midspan. The repaired ultimate load was 120 kN (27 kips) at a displacement of 49 mm (1.93 in.). Horizontal sliding was observed at the support face during this period of deflection.

Figure 102. Load-deflection curves for stringers C5 and C5-R.

The increase in the repaired ultimate load over the unstrengthened postfailure capacity was 50% for the repaired stringer C5-R. This increase was greater than that observed in timber stringers C3-R and C4-R and lower than for stringer C2-R. Timber stringer C5 developed horizontal and tension cracks as explained in Chapter 5, “Test results and discussion, Test results of original stringers, Specimen C5.” Stringer C5 was repaired using hex bolts with steel plates. A compression force in the transverse direction was applied using the steel plates at the top and bottom of the stringer which increased the stiffness at the beginning of load-deflection curve until the load reached 45 kN (10 kips). Above 45 kN (10 kips), stiffness of stringer C5-R was again lower than that of stringer C5. The original and repaired ultimate loads were 169 kN (38 kips) and 121 kN (27 kips) for stringers C5 and C5-R, respectively. This was 71% recovery in the ultimate load of stringer C5-R with respect to stringer C5.

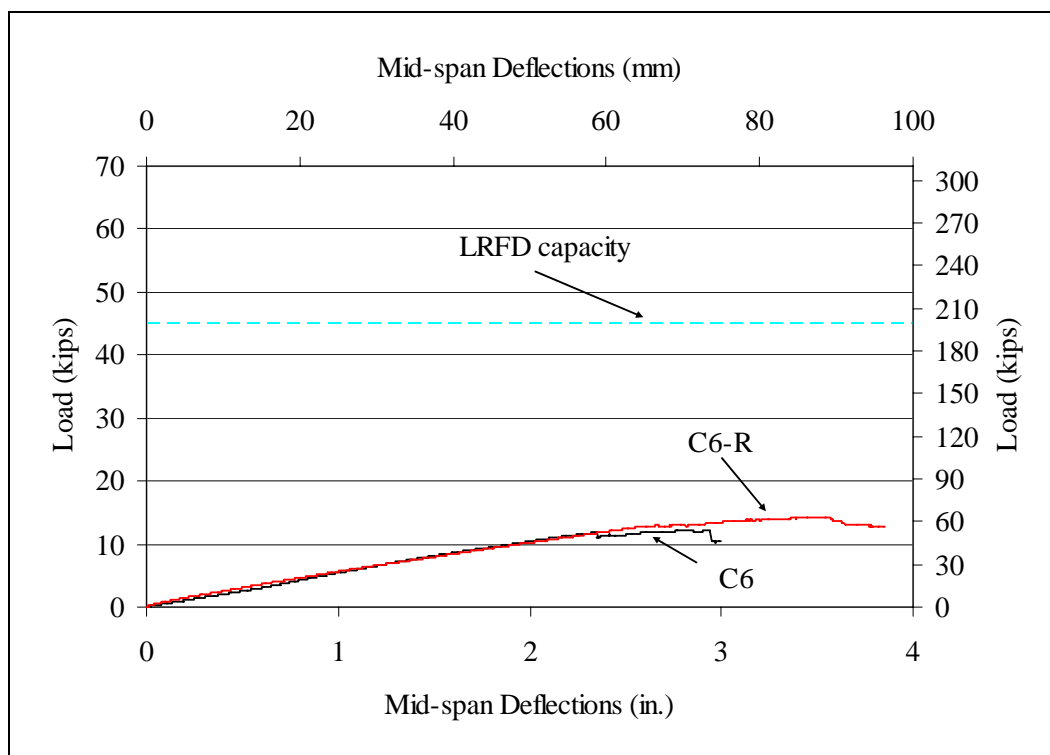
The load-deflection curve for stringer C6-R, shown in Figure 103, was linear until the stringer cracked in the tension zone. Several tension cracks and tension splinters near the midspan were visible, which were caused by excessive deformation. The repaired ultimate load carried by the stringer was 62 kN (14 kips) at a displacement of 90 mm (3.56 in.). As the load increased to failure, horizontal sliding occurred at the support faces. A lag screw spacing of 305 mm (1 ft) was used for stringer C6-R, which resulted in a strength increase over the unstrengthened postfailure capacity of 16.7%. This was a lower increase than the timber stringers repaired with hex bolts and lag screws because of the preexisting end splitting on timber stringer C6. The tension cracks that developed in the tension zone of stringer C6 affected the repair method, as discussed in Chapter 5, “Test results and discussion, Test results of original stringers, Specimen C6.” There was no increase in the slope of the load-deflection curve of timber stringer C6-R. As for stringer C5-R, steel plates could have been utilized on stringer C6-R to apply compressive pressure to close the end splitting gap and to increase the stiffness of split timber stringers.

Figure 103. Load-deflection curves for stringers C6 and C6-R.

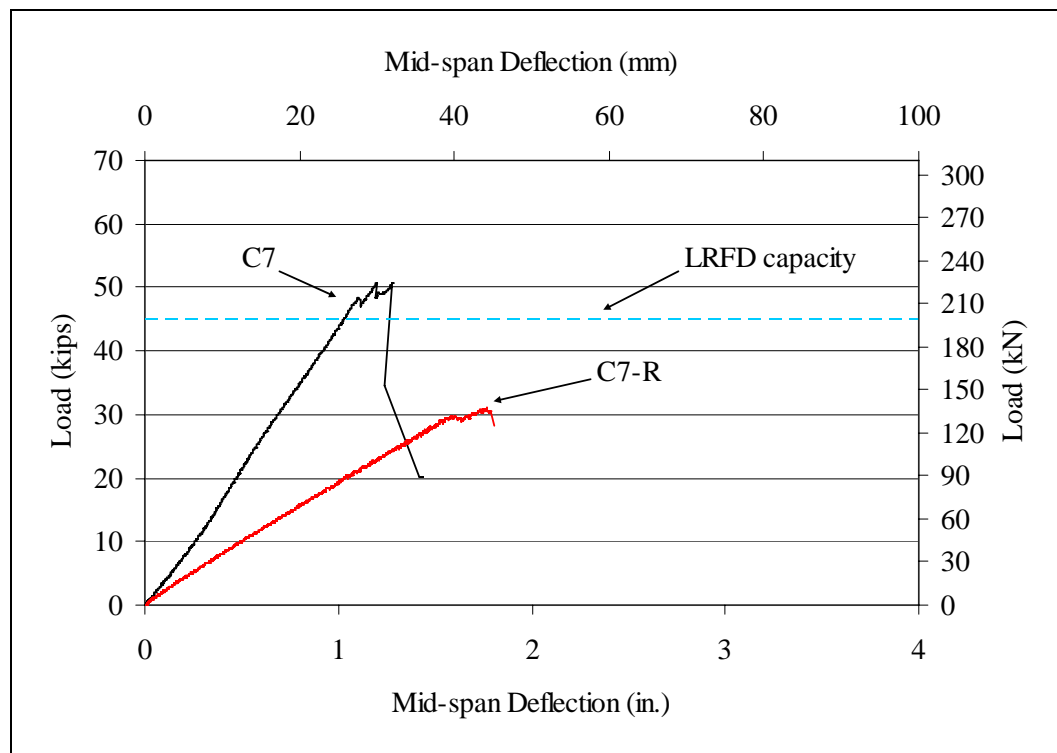
The load-deflection curve for stringer C7-R, seen in Figure 104, was linear until the stringer failed in the tension zone with several tension splinters, which caused a drop in the supported load. The repaired ultimate load at the failure was 138 kN (31 kips) at a displacement of 45 mm (1.77 in.). Horizontal sliding occurred at the support faces as the load approached failure. Stringer C10-R behaved linearly until it reached the ultimate load, as seen in the load-deflection curve shown in Figure 105. As the load increased to failure, horizontal sliding occurred at the support face. The repaired ultimate load resisted by the stringer was 196 kN (44 kips) at a displacement of 51 mm (2.02 in.). The stringer failed in simple tension at 187 kN (42 kips) at a displacement of 58 mm (2.3 in.).

Figure 104. Load-deflection curves for stringers C7 and C7-R.

The increase in the repaired ultimate load over the unstrengthened postfailure capacity was 55% and 100% for stringers C7-R and C10-R, respectively. These stringers were repaired using lag screws making a 45° angle with the transverse direction. Stringers C7 and C10 developed horizontal shear cracks before the repair which made the repair scheme effective. The original and repaired ultimate loads were 227 kN (51 kips) and 138 kN (31 kips) for stringers C7 and C7-R, respectively. This represents a 61% recovery for stringer C7-R, although the increase in unstrengthened postfailure capacity was 55%. The lag screws layout used in stringer C10-R; therefore, produced a more effective repair than the layout used in stringer C7-R.

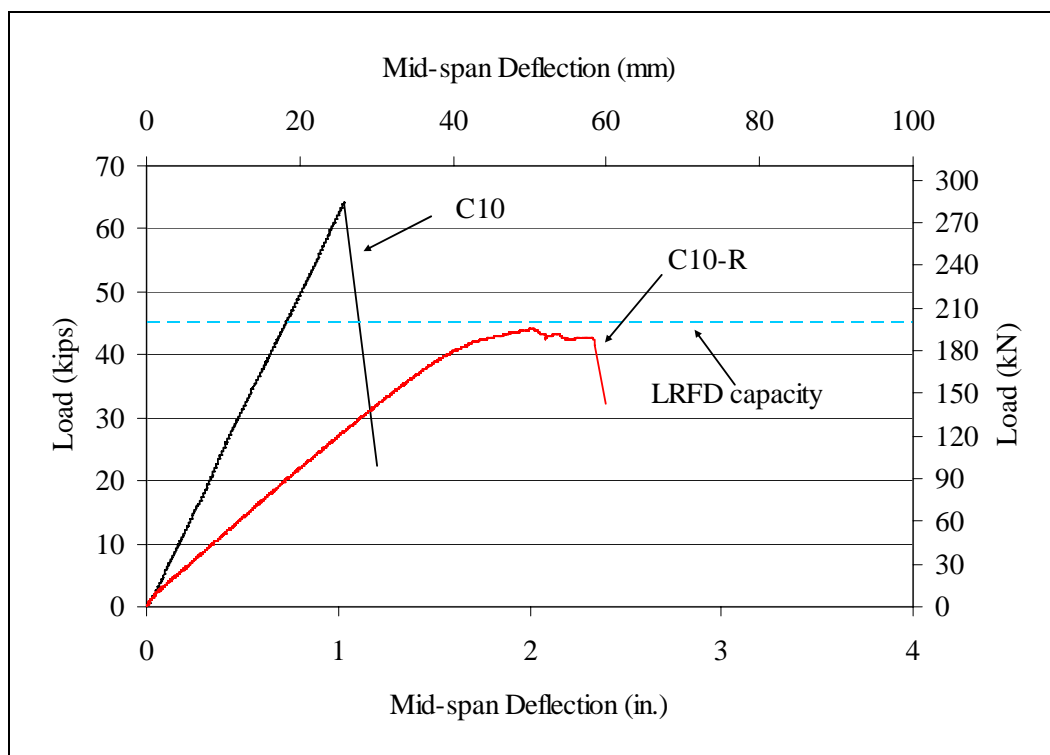
Figure 105. Load-deflection curves for stringers C10 and C10-R.

The original and repaired ultimate loads were 285 kN (64 kips) and 196 kN (44 kips) for stringers C10 and C10-R, respectively. Stringer C10-R recovered 69% of the ultimate load of stringer C10. Using lag screws did not restore the stiffness of stringers C7-R and C10-R to their original unsplit stiffness. Stringers C7-R and C10-R developed tension cracks at failure.

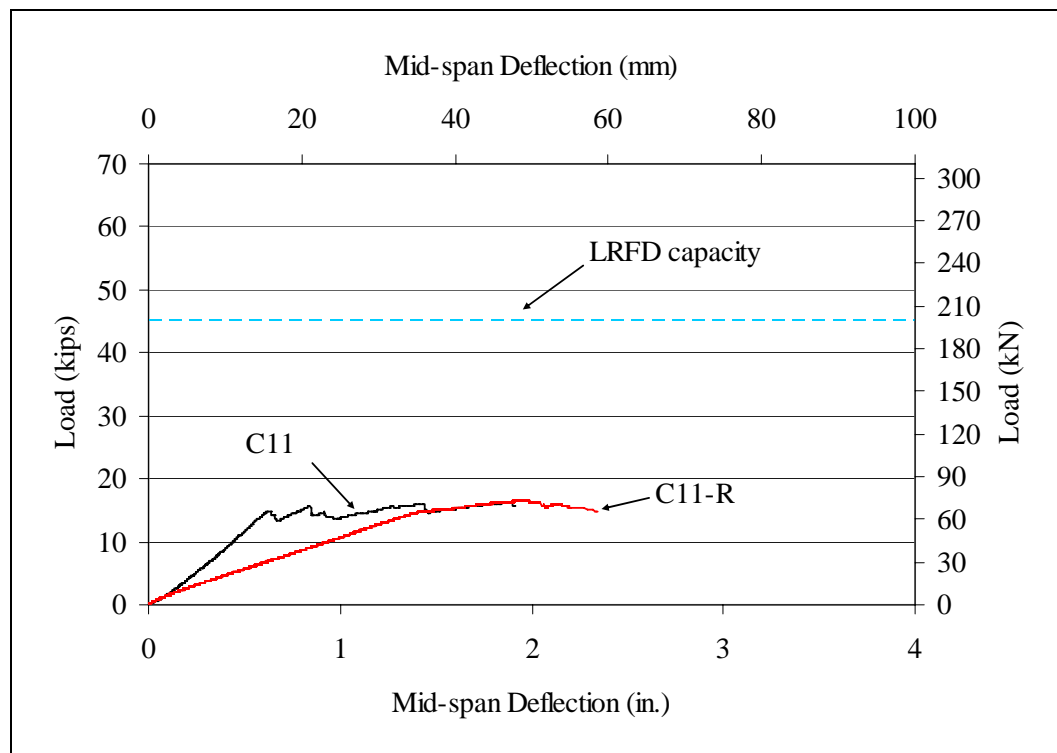
Stringer C11-R behaved linearly up to the repaired ultimate load, as seen in the load-deflection curve shown in Figure 106. The stringer developed tension cracks near the midspan at the repaired ultimate load. The repaired ultimate load carried by the stringer was 71 kN (16 kips) at a displacement of 52 mm (2.05 in.). Horizontal sliding occurred at the support faces as the load approached failure.

Figure 106. Load-deflection curves for stringers C11 and C11-R.

A lag screw spacing of 610 mm (2 ft) was used to repair stringers C11-R and C15-R. The increase in the repaired ultimate load over the unstrengthened postfailure capacity was 6.3% and 4.8%, which were the lowest values among all of the repaired timber stringers. Stringer C11 was severely deteriorated at one end support before testing, as explained in Chapter 3, “Repair systems for stringers, Timber specimens, Specimen C11,” which caused this lower percent increase in strength for the repaired stringer C11-R. These stringers also had lower stiffness than the original stringers with end split.

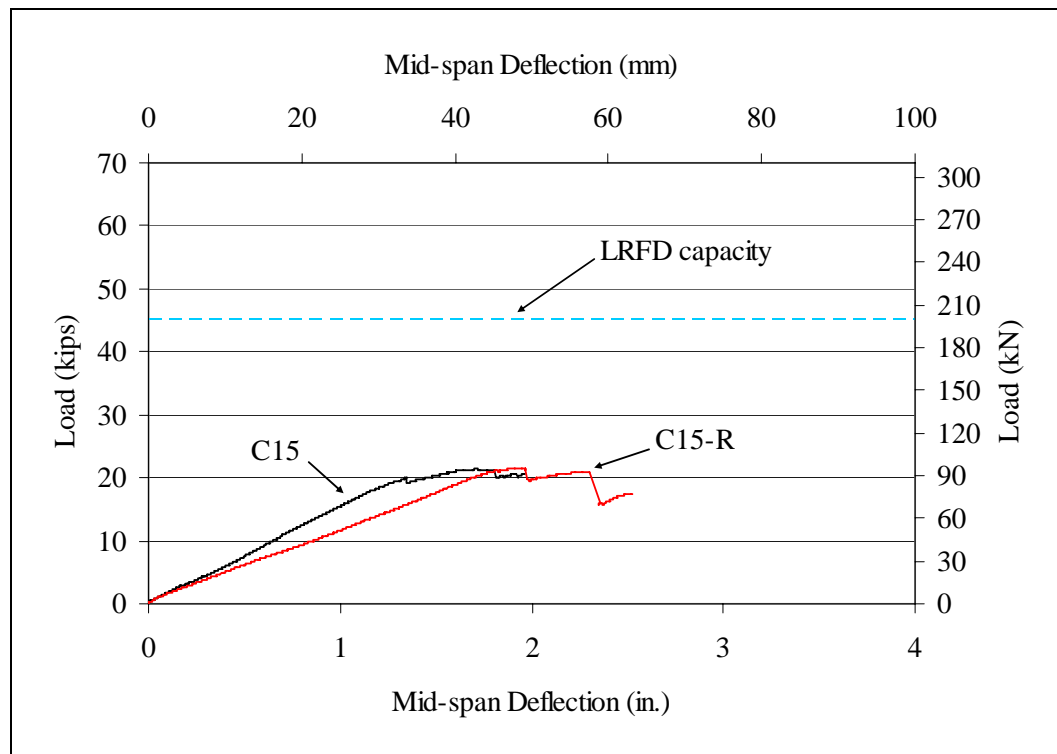
Stringer C15-R behaved linearly until it reached a load of 93 kN (21 kips), as seen in the load-deflection curve shown in Figure 107. The stringer then cracked in the tension zone causing a small drop in the supported load. The stringer then gained load capacity up to 98 kN (22 kips) where crushing started and the timber cracked again in tension. The stringer failed in tension and developed several cracks and tension splinters at the midspan. The repaired ultimate load was 98 kN (22 kips) at a displacement of 50 mm (1.96 in.).

Figure 107. Load-deflection curves for stringers C15 and C15-R.

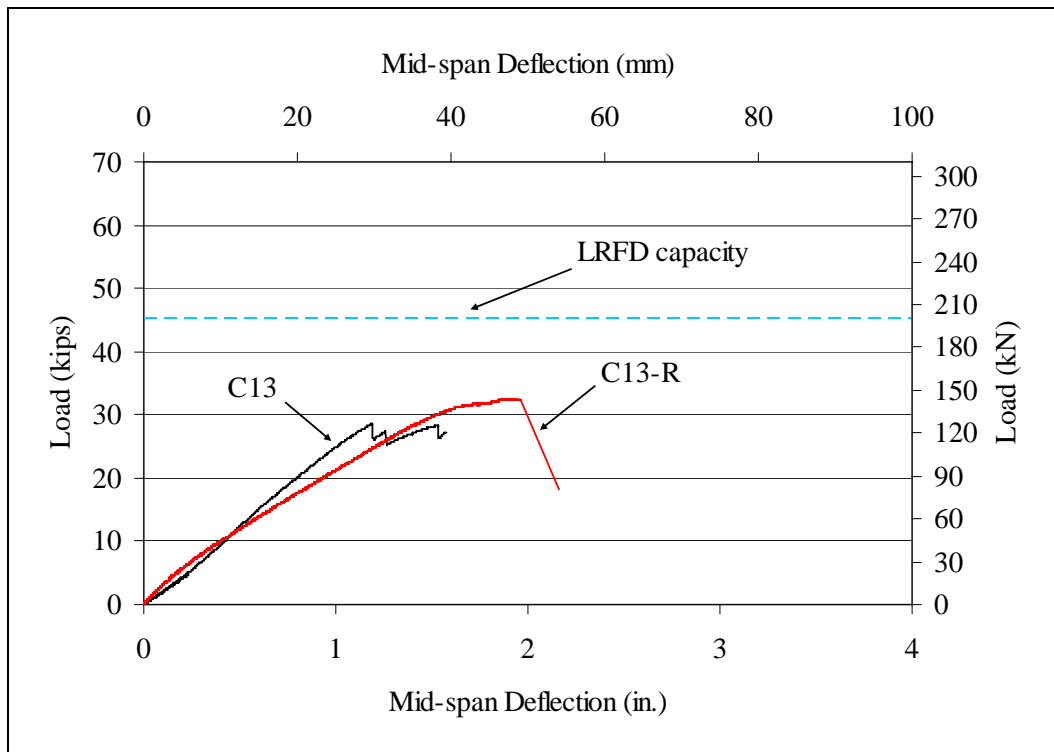
Stringer C13-R behaved linearly until it reached its repaired ultimate load, as seen in the load-deflection curve shown in Figure 108. As the load approached failure, buckling and horizontal cracks occurred in one of the side repair plates, as seen in Figure 109. There was no other damage observed in the plywood side plates. The stringers then failed in the tension zone causing a drop in the supported load. The repaired ultimate load was 142 kN (32 kips) at a displacement of 50 mm (1.95 in.). Tension cracks and splinters occurred at the midspan at failure. Following the test, the plywood side plates were removed and inspected for additional

Figure 108. Load-deflection curves for stringers C13 and C13-R.

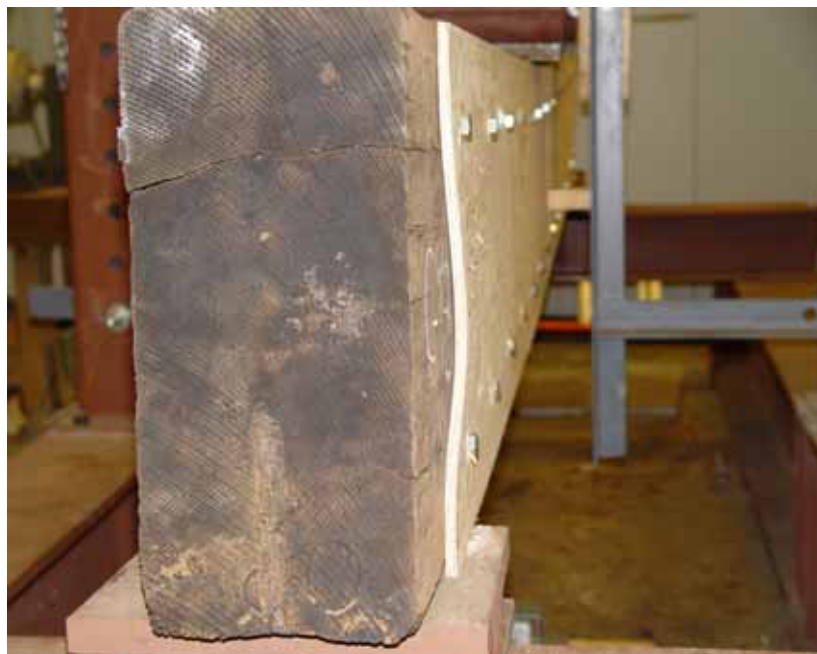
damage. There was bearing damage at the holes where they were attached and horizontal cracks along the length of the plates.

Figure 109. Buckling of the side plate on stringer C13-R.

Plywood side plates were used to repair stringer C13-R which had severe end splitting prior to testing. The increase in the repaired ultimate load over the unstrengthened postfailure capacity of the stringer was 14.3%, which was higher than the stringers repaired with lag screws. The stiffness of the repaired stringer was higher than that of stringer C13 up to a load of 45 kN (10 kips), as shown in Figure 108. The plywood plates developed bearing damage at the holes where they were attached, horizontal cracks along the length of the plywood plates, and several horizontal surface cracks along their lengths.

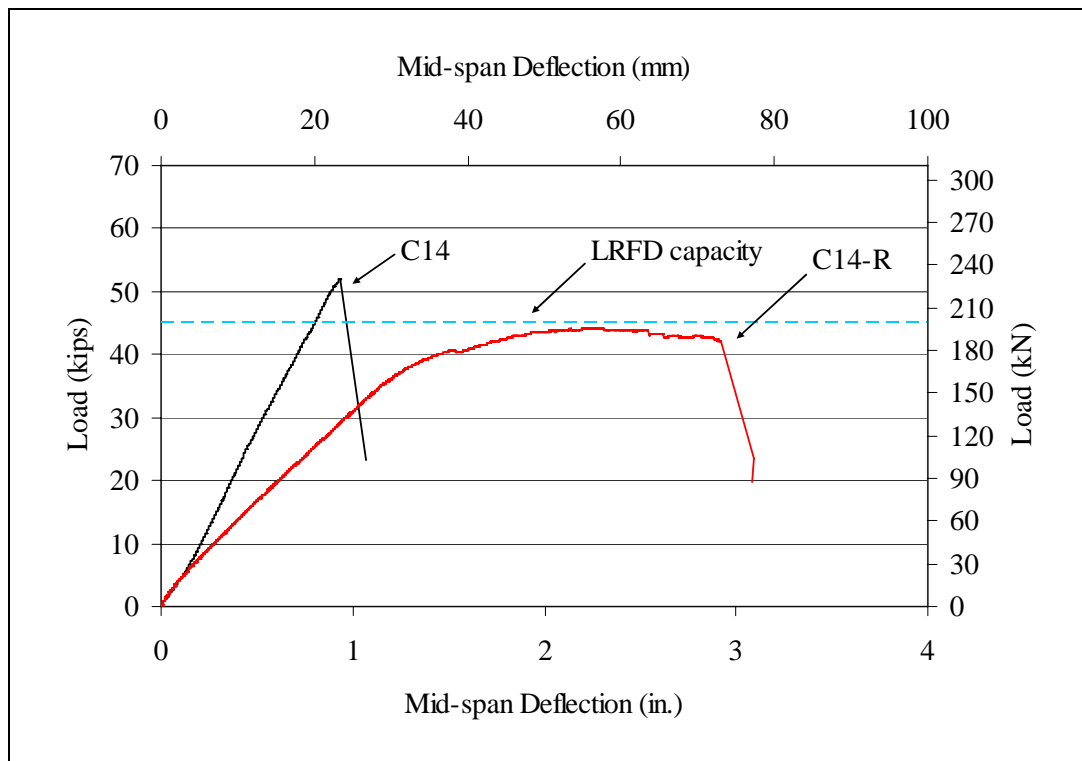
The load-deflection curve for stringer C14-R, shown in Figure 110, was linear until the stringer reached a load of 182 kN (41 kips). As the load approached ultimate failure load, horizontal sliding occurred at the support face. The repaired ultimate load was 196 kN (44 kips) at a displacement of 57 mm (2.24 in.). The stringer underwent a deflection of 23 mm (0.9 in.) without any increase in load capacity after the stringer reached the repaired ultimate load. The stringer developed tension cracks and compression failure at a load of 187 kN (42 kips) and a displacement of 74 mm (2.92 in.) causing a drop in the load capacity. The compression failure is shown in Figure 111. The experiment was terminated at this point due to excessive deformation. The side plates had minor bearing damage at the holes where they were attached, as seen in Figure 112.

Figure 110. Load-deflection curves for stringers C14 and C14-R.

Timber stringer C14-R was repaired using FRP side plates. The increase in the repaired ultimate load over the unstrengthened postfailure capacity was 91%. This repair method was more effective. It yielded 18.6% higher strength than stringer C2-R repaired with hex bolts, but 9% lower strength than stringer C10-R repaired with lag screws. Stringer C14 developed a horizontal shear crack at failure, as explained in Chapter 5, “Test results and discussion, Test results of original stringers, Specimen C14.” Stiffness of the repaired stringer C14-R, shown in Figure 110, was also below the stiffness of stringer C14, as the other repaired stringers.

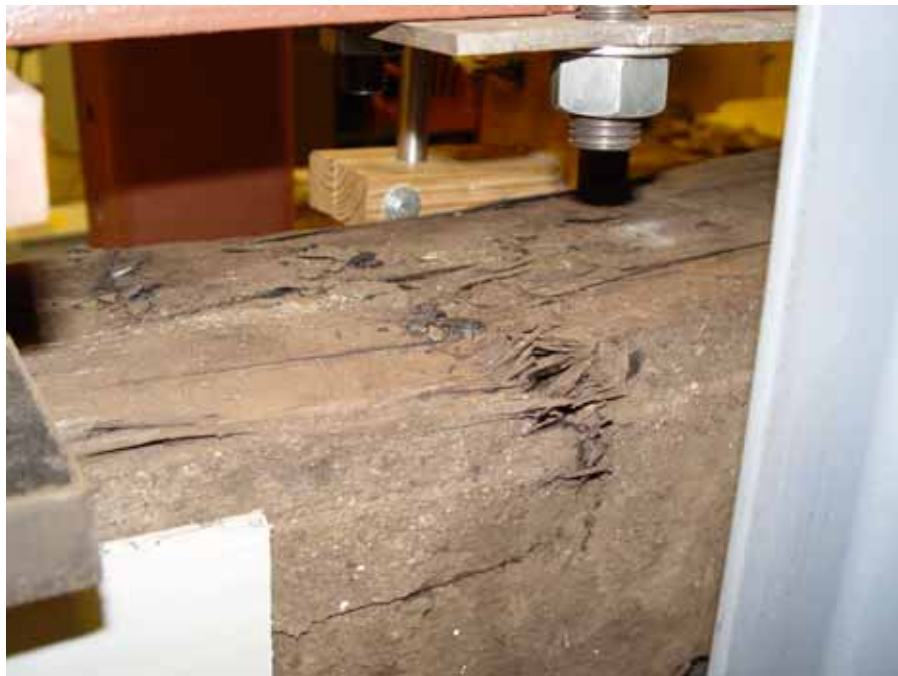
Figure 111. Compression failures due to excessive deformations on stringer C14-R.

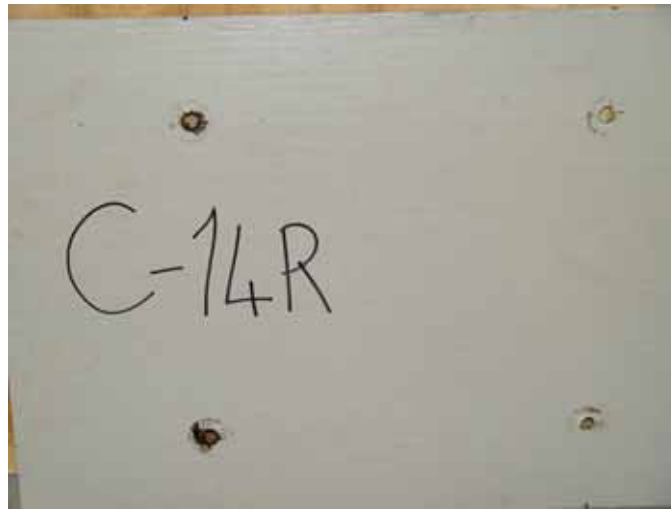
Figure 112. Minor bearing damages at the holes on FRP plates.
